Safety Notice 1 of 2003: SL 17 A/B & MK 21 Neck clamp 28 Aug. 2003

Subject: Neck Clamp Assembly
KMDSI Part # 505-055 (and pre '89 505-003)

Products Affected: Kirby Morgan SuperLite-17A/B & U.S. Navy MK-21 Mod. O & Mod. I Helmets

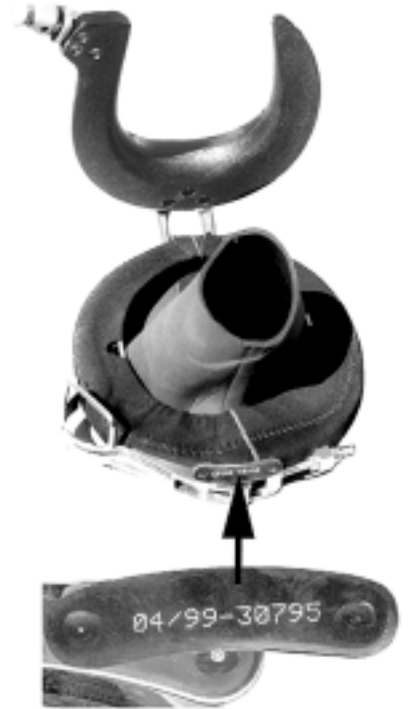
All metal parts should be inspected for cracks or corrosion and replaced immediately if this type of damage is found. While some surface rust or corrosion is to be expected, severe corrosion can lead to the eventual failure of the part.

If any part doesn't look right, don't use it.
